## LIGHTER SUITE 7.2.1 – RELEASE NOTES

This document describes the SW Release **LIGHTER 7.2.1** for **Laser Marking** devices. It is a maintenance release that fixes some bugs related to embedded PROFINET, limits function, and axes. The upgrade of LM devices to this release is not mandatory.

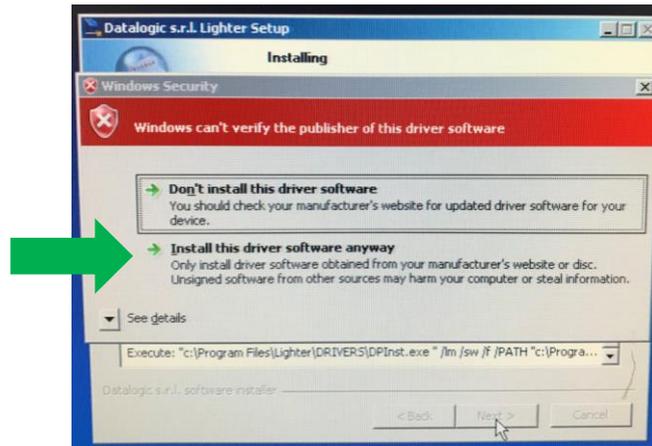
During installation on **AREX400**, **UNIQ** and **AREX20-MW** models, the iMarkII control board driver software version **1.0.4 15347** will be required to install. **NB:** driver may not be signed in some PCs (see also known issue #63370). Select '*Install this driver software anyway*' to proceed:

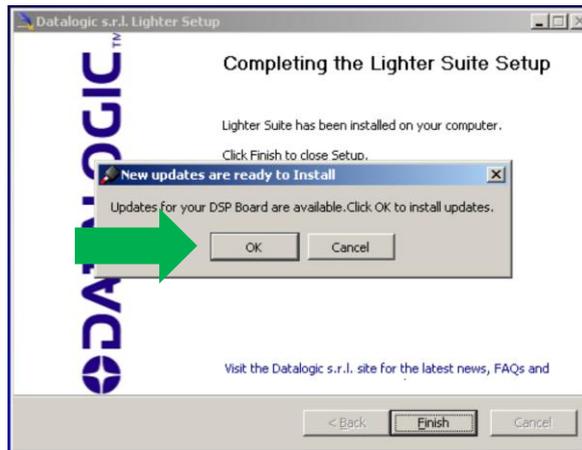
This upgrade fixes some problems related to slow PCI bus communication, unresponsive mouse/keyboard peripherals, slow operative system, unstable communication with *Fiber Configurator* (for AREX) serial application.

During LIGHTER upgrade, when prompted by a message box **“Updates for your DSP Board are available”**, click *OK* to install the updates:

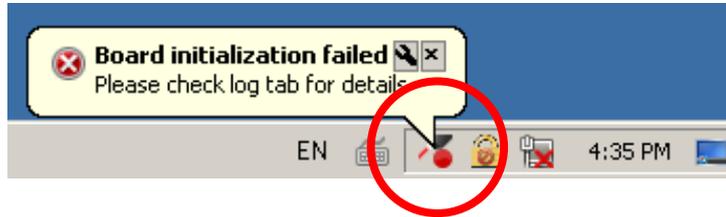
At the next power-on after an upgrade to 7.2.1, *LaserEngine* will go in “Simulation mode”. Check the following clues:

- A. Red *LaserEngine* icon, even when KEY=0 and ENABLE=0.  
Popup “**Board initialization failed. Check log tab for details**”.

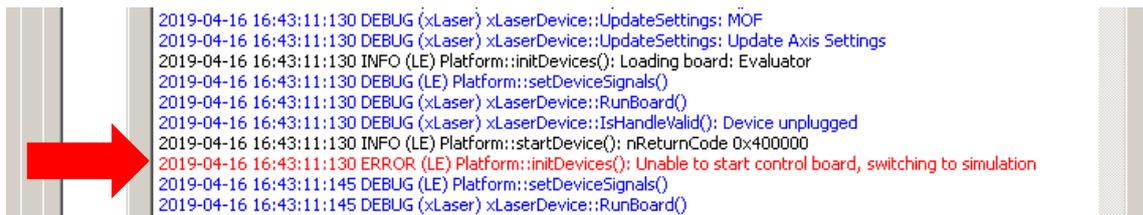
- C. Entry in *LaserEngine* log “**ERROR(LE) Platform::initDevices(): Unable to start control board, switching to simulation**”.

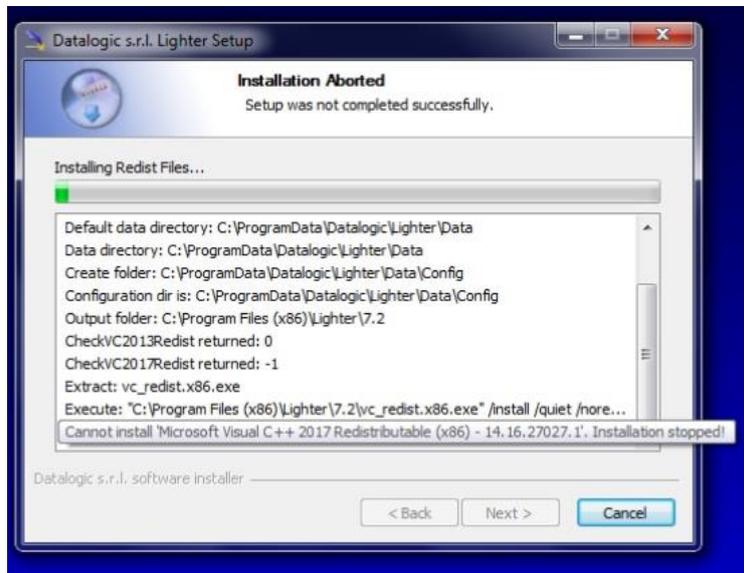
If newer versions of any redistributables are found installed ex. on a laptop, LIGHTER Suite installer will abort with *'Cannot install 'Microsoft Visual C++ [...] Redistributable [...]' Installation stopped'* :

You can apply the workaround of uninstalling the newer redistributables, launch and finish LIGHTER Suite installer, and finally reinstalling your redistributables.
